# CCR Annual Inspection §257.83 (b)

Ash Pond

## A.B. Brown Generating Station

### Revision 0

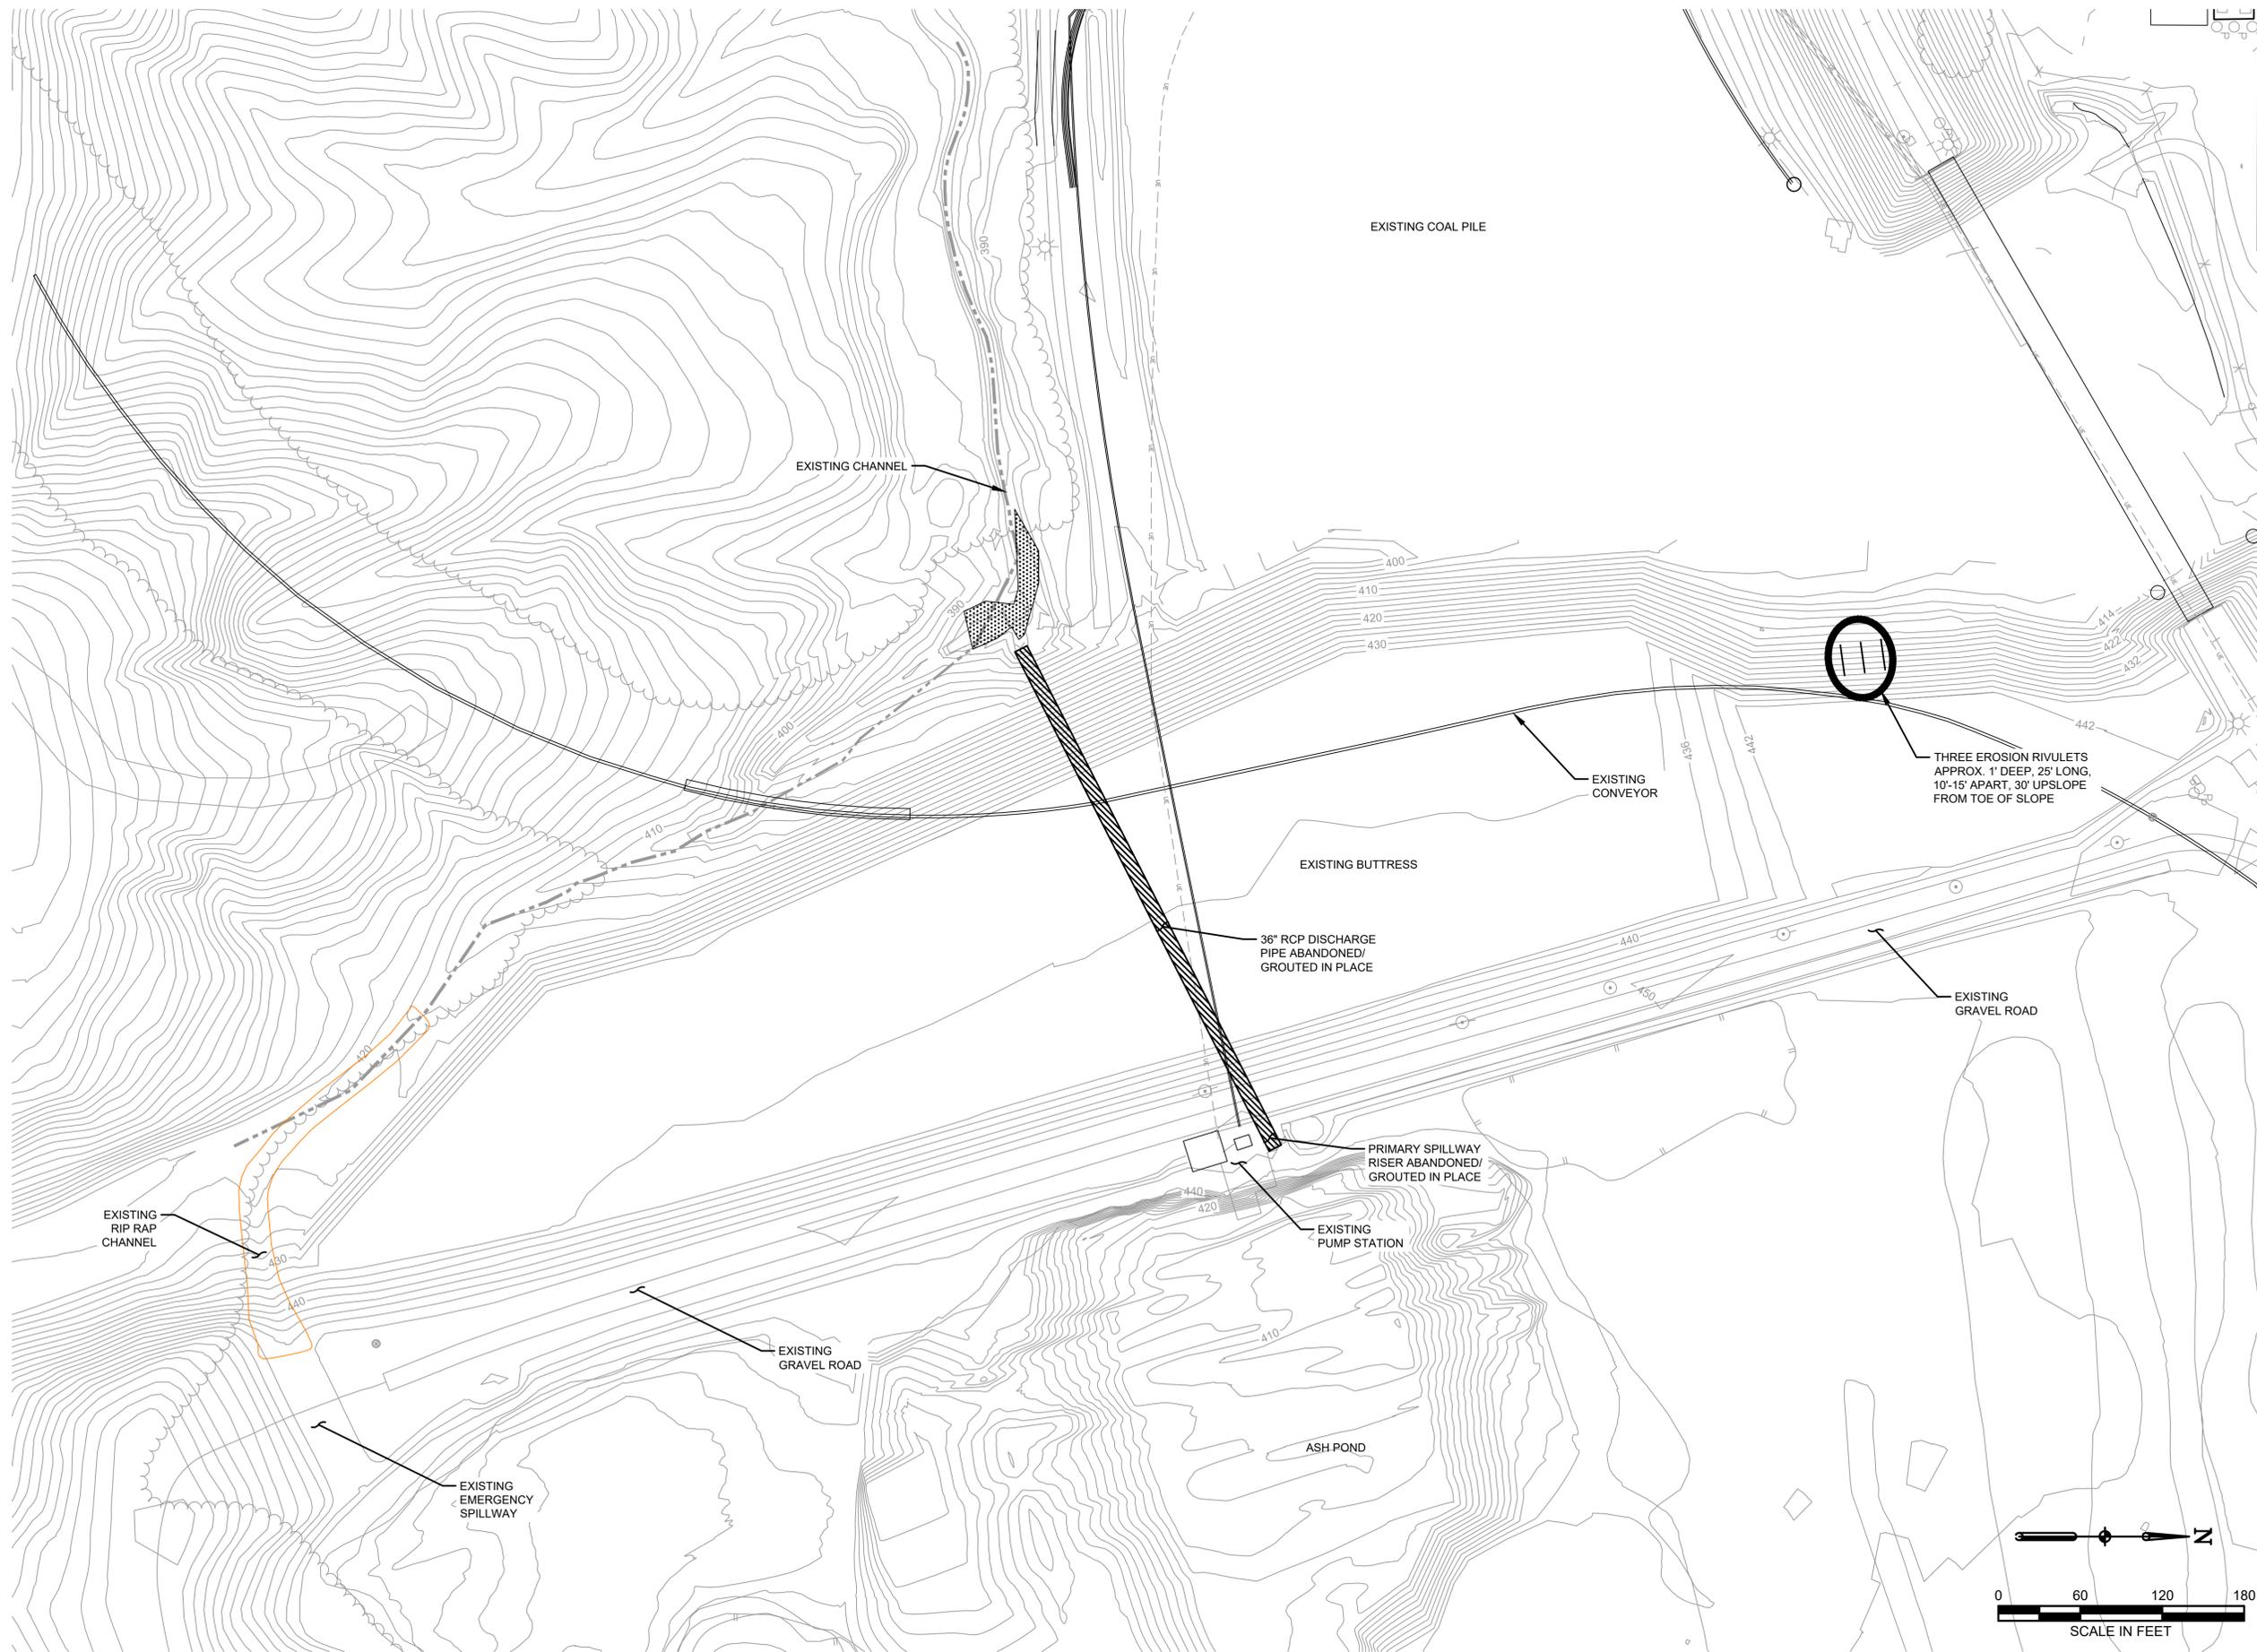
**FIGURE 3**

Table 2-2 – Areas of Concern (Inspected: October 26, 2022)	
Deficiency/Observation	Proposed Corrective Measure
Three erosion rivulets approximately 12" deep, 25' long, 10' - 15' apart, approximately 30' upslope from the northern toe of buttress slope were identified adjacent to each other. See Figure 3.	Erosion ruts to be filled, regraded and seeded/mulched.
