July 19, 2018

CCR Annual Inspection

West Ash Pond

F. B. Culley Generating Station

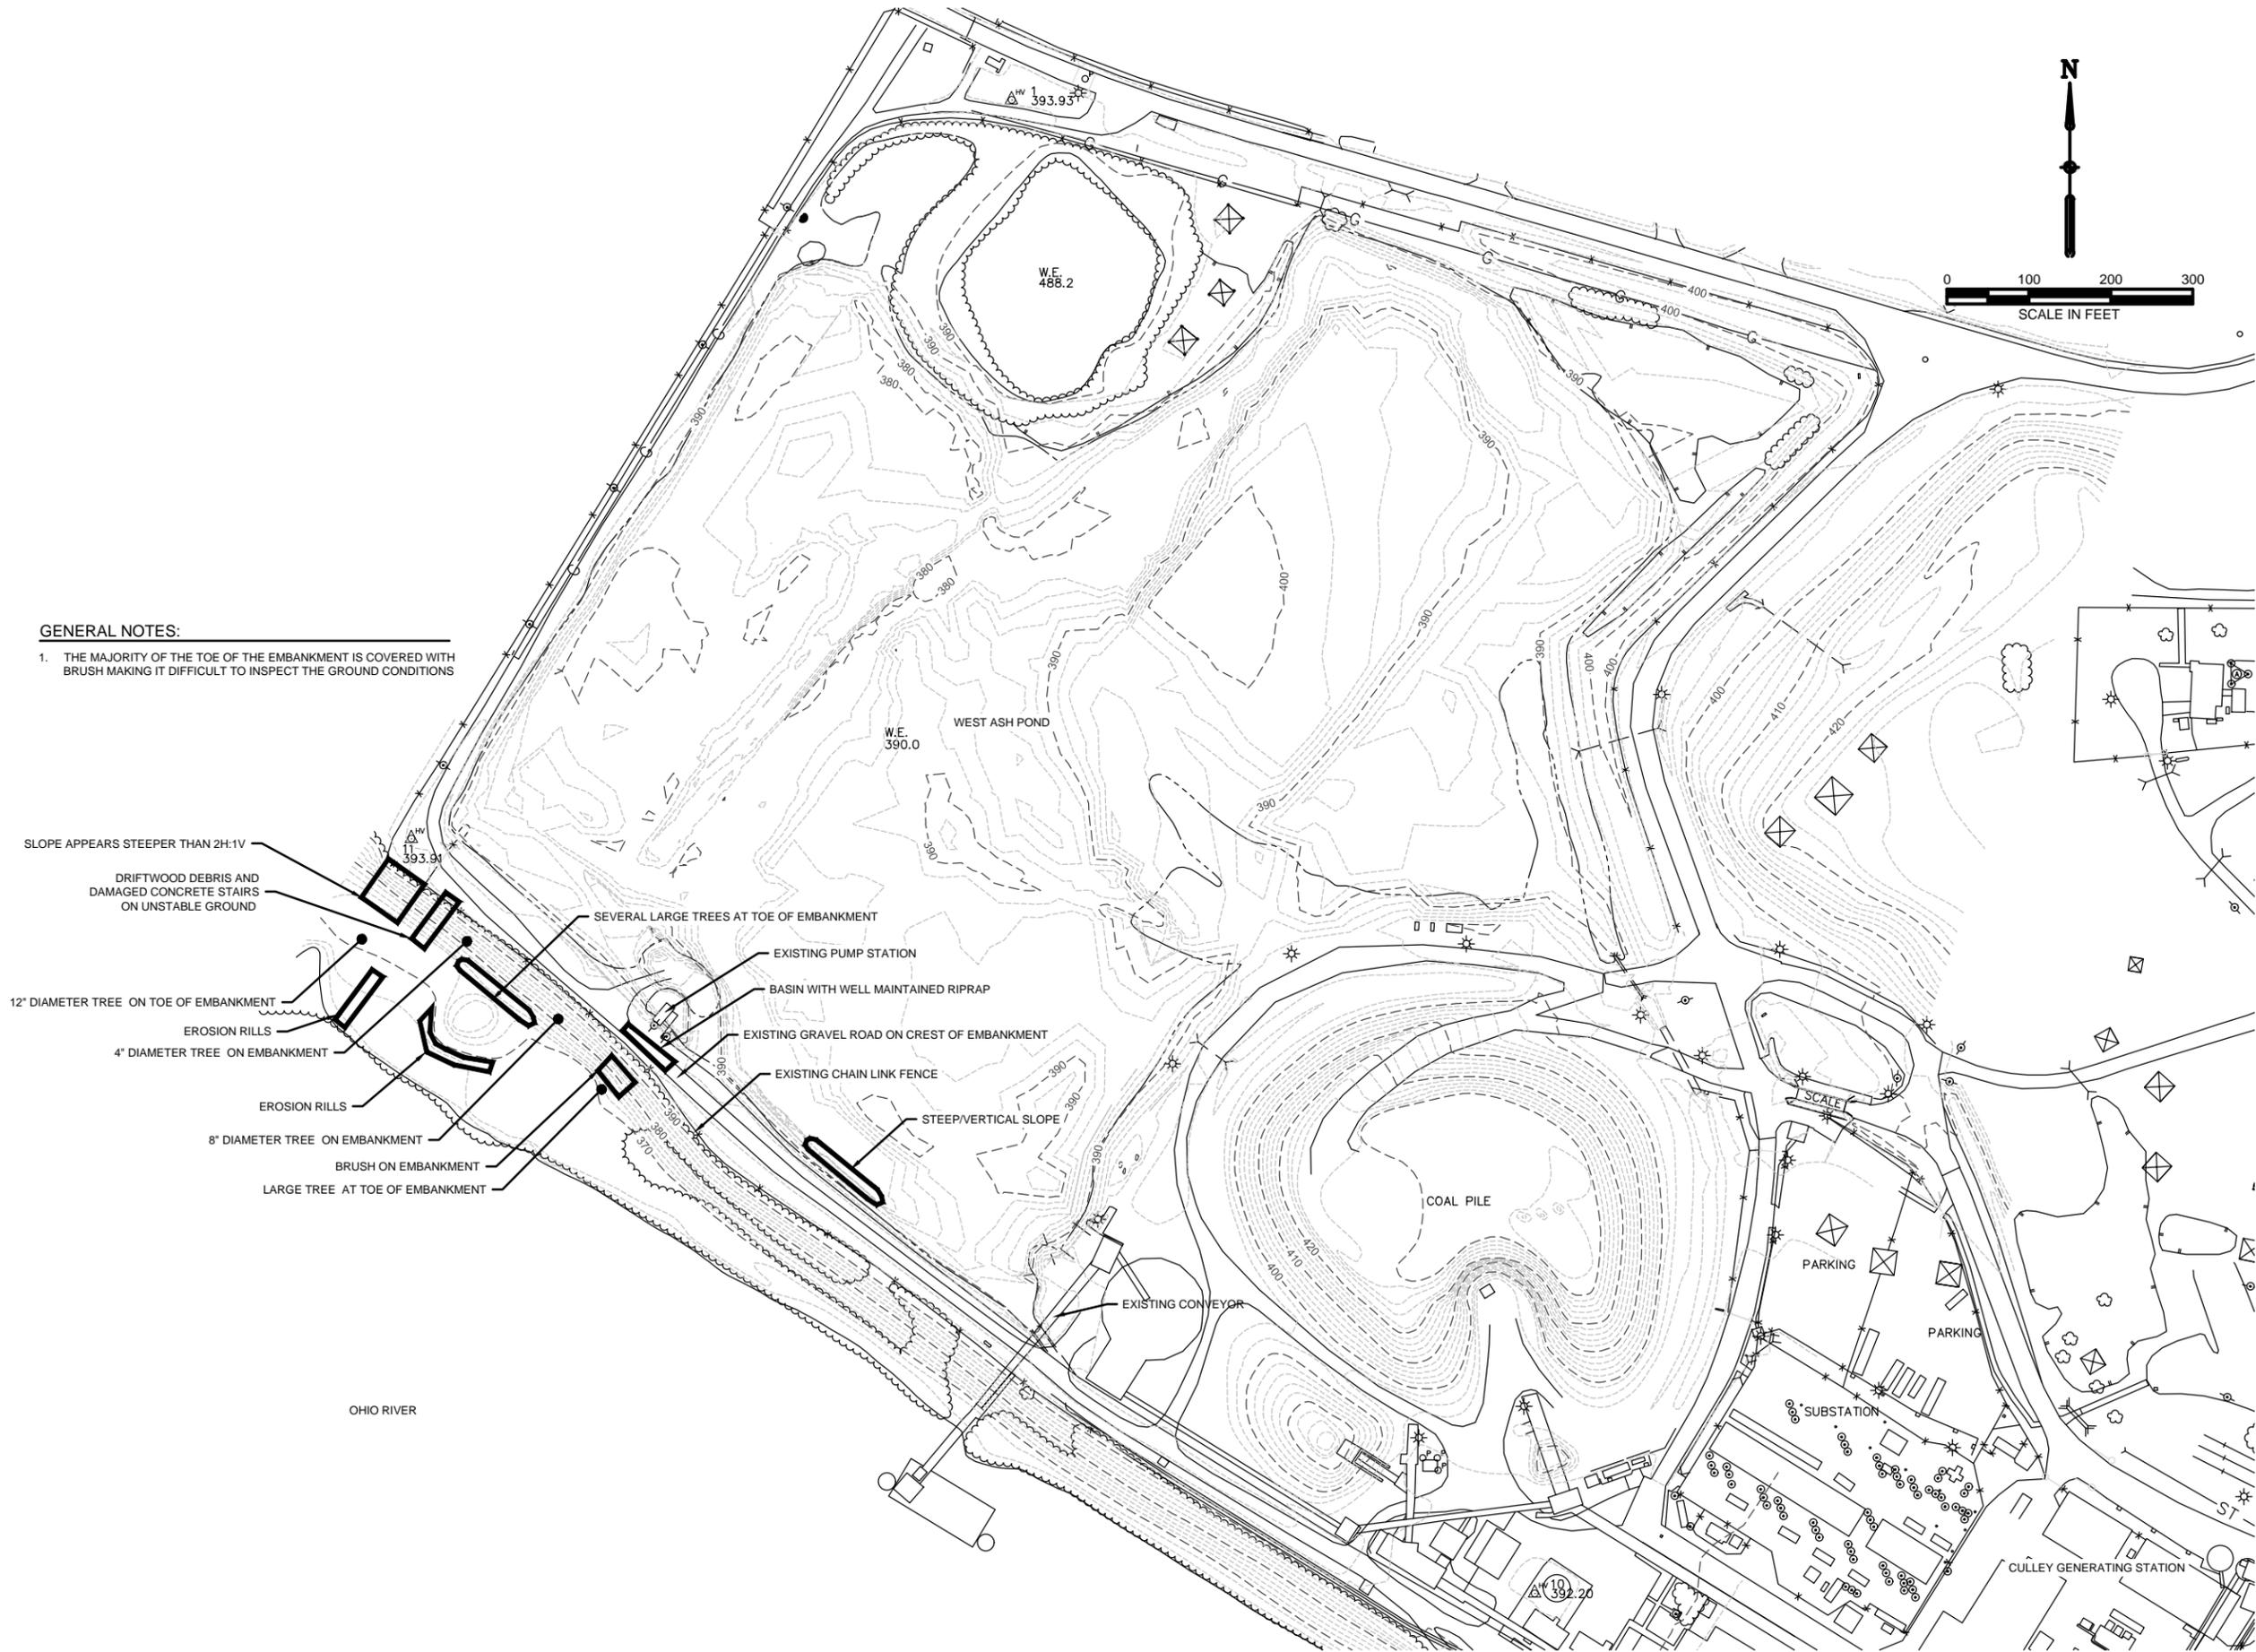
FIGURE 3

Deficiency/Observation	Proposed Corrective Measure
Exterior Slope – A few small trees/bushes and brush have grown on the embankment slope.	Continue monitoring. Cut small trees/bushes to a level flush with the ground surface (so as to not disturb the subsurface) and spray remaining vegetation.
Exterior Slope – Concrete stairs leading to the Ohio River are dilapidated. Unstable terrain underlies collapsing stairs.	Damaged stairs to be removed and unstable areas regraded as necessary.
<p>Toe of Embankment Slope – There are several large trees and overgrown brush at the toe of slope.</p> <p>As stated previously in Table 2-2, the majority of the trees on the downstream slope of the embankment are at the toe and no seepage was observed in this area. No visual evidence was observed of stability concerns (i.e., sloughing, depressions, erosion, etc.)</p>	<p>Continue monitoring. Based on these observations and the size and extent of the trees, AECOM believes removing these trees at this time would result in significant disturbance to the unit, which could destabilize the embankment and could promote excessive erosion during high rainfall events. It is our opinion that the trees are currently necessary for stabilization of the embankment and are better left in place.</p> <p>Monitor brush and spray/remove if it continues to encroach onto embankment slope.</p>

- SLOPE APPEARS STEEPER THAN 2H:1V
- DRIFTWOOD DEBRIS AND DAMAGED CONCRETE STAIRS ON UNSTABLE GROUND
- 12" DIAMETER TREE ON TOE OF EMBANKMENT
- EROSION RILLS
- 4" DIAMETER TREE ON EMBANKMENT
- EROSION RILLS
- 8" DIAMETER TREE ON EMBANKMENT
- BRUSH ON EMBANKMENT
- LARGE TREE AT TOE OF EMBANKMENT

- SEVERAL LARGE TREES AT TOE OF EMBANKMENT
- EXISTING PUMP STATION
- BASIN WITH WELL MAINTAINED RIPRAP
- EXISTING GRAVEL ROAD ON CREST OF EMBANKMENT
- EXISTING CHAIN LINK FENCE
- STEEP/VERTICAL SLOPE
- EXISTING CONVEYOR
