Submitted to
Southern Indiana
Gas & Electric Company
(SIGECO)
211 NW Riverside Drive
Evansville, IN 47708

Submitted by
AECOM
13640 Briarwick Drive
Austin, Texas 78729
October 13, 2023

CCR Annual Inspection
§257.83 (b)
for the
East Ash Pond
at the
F. B. Culley Generating Station
Revision 0

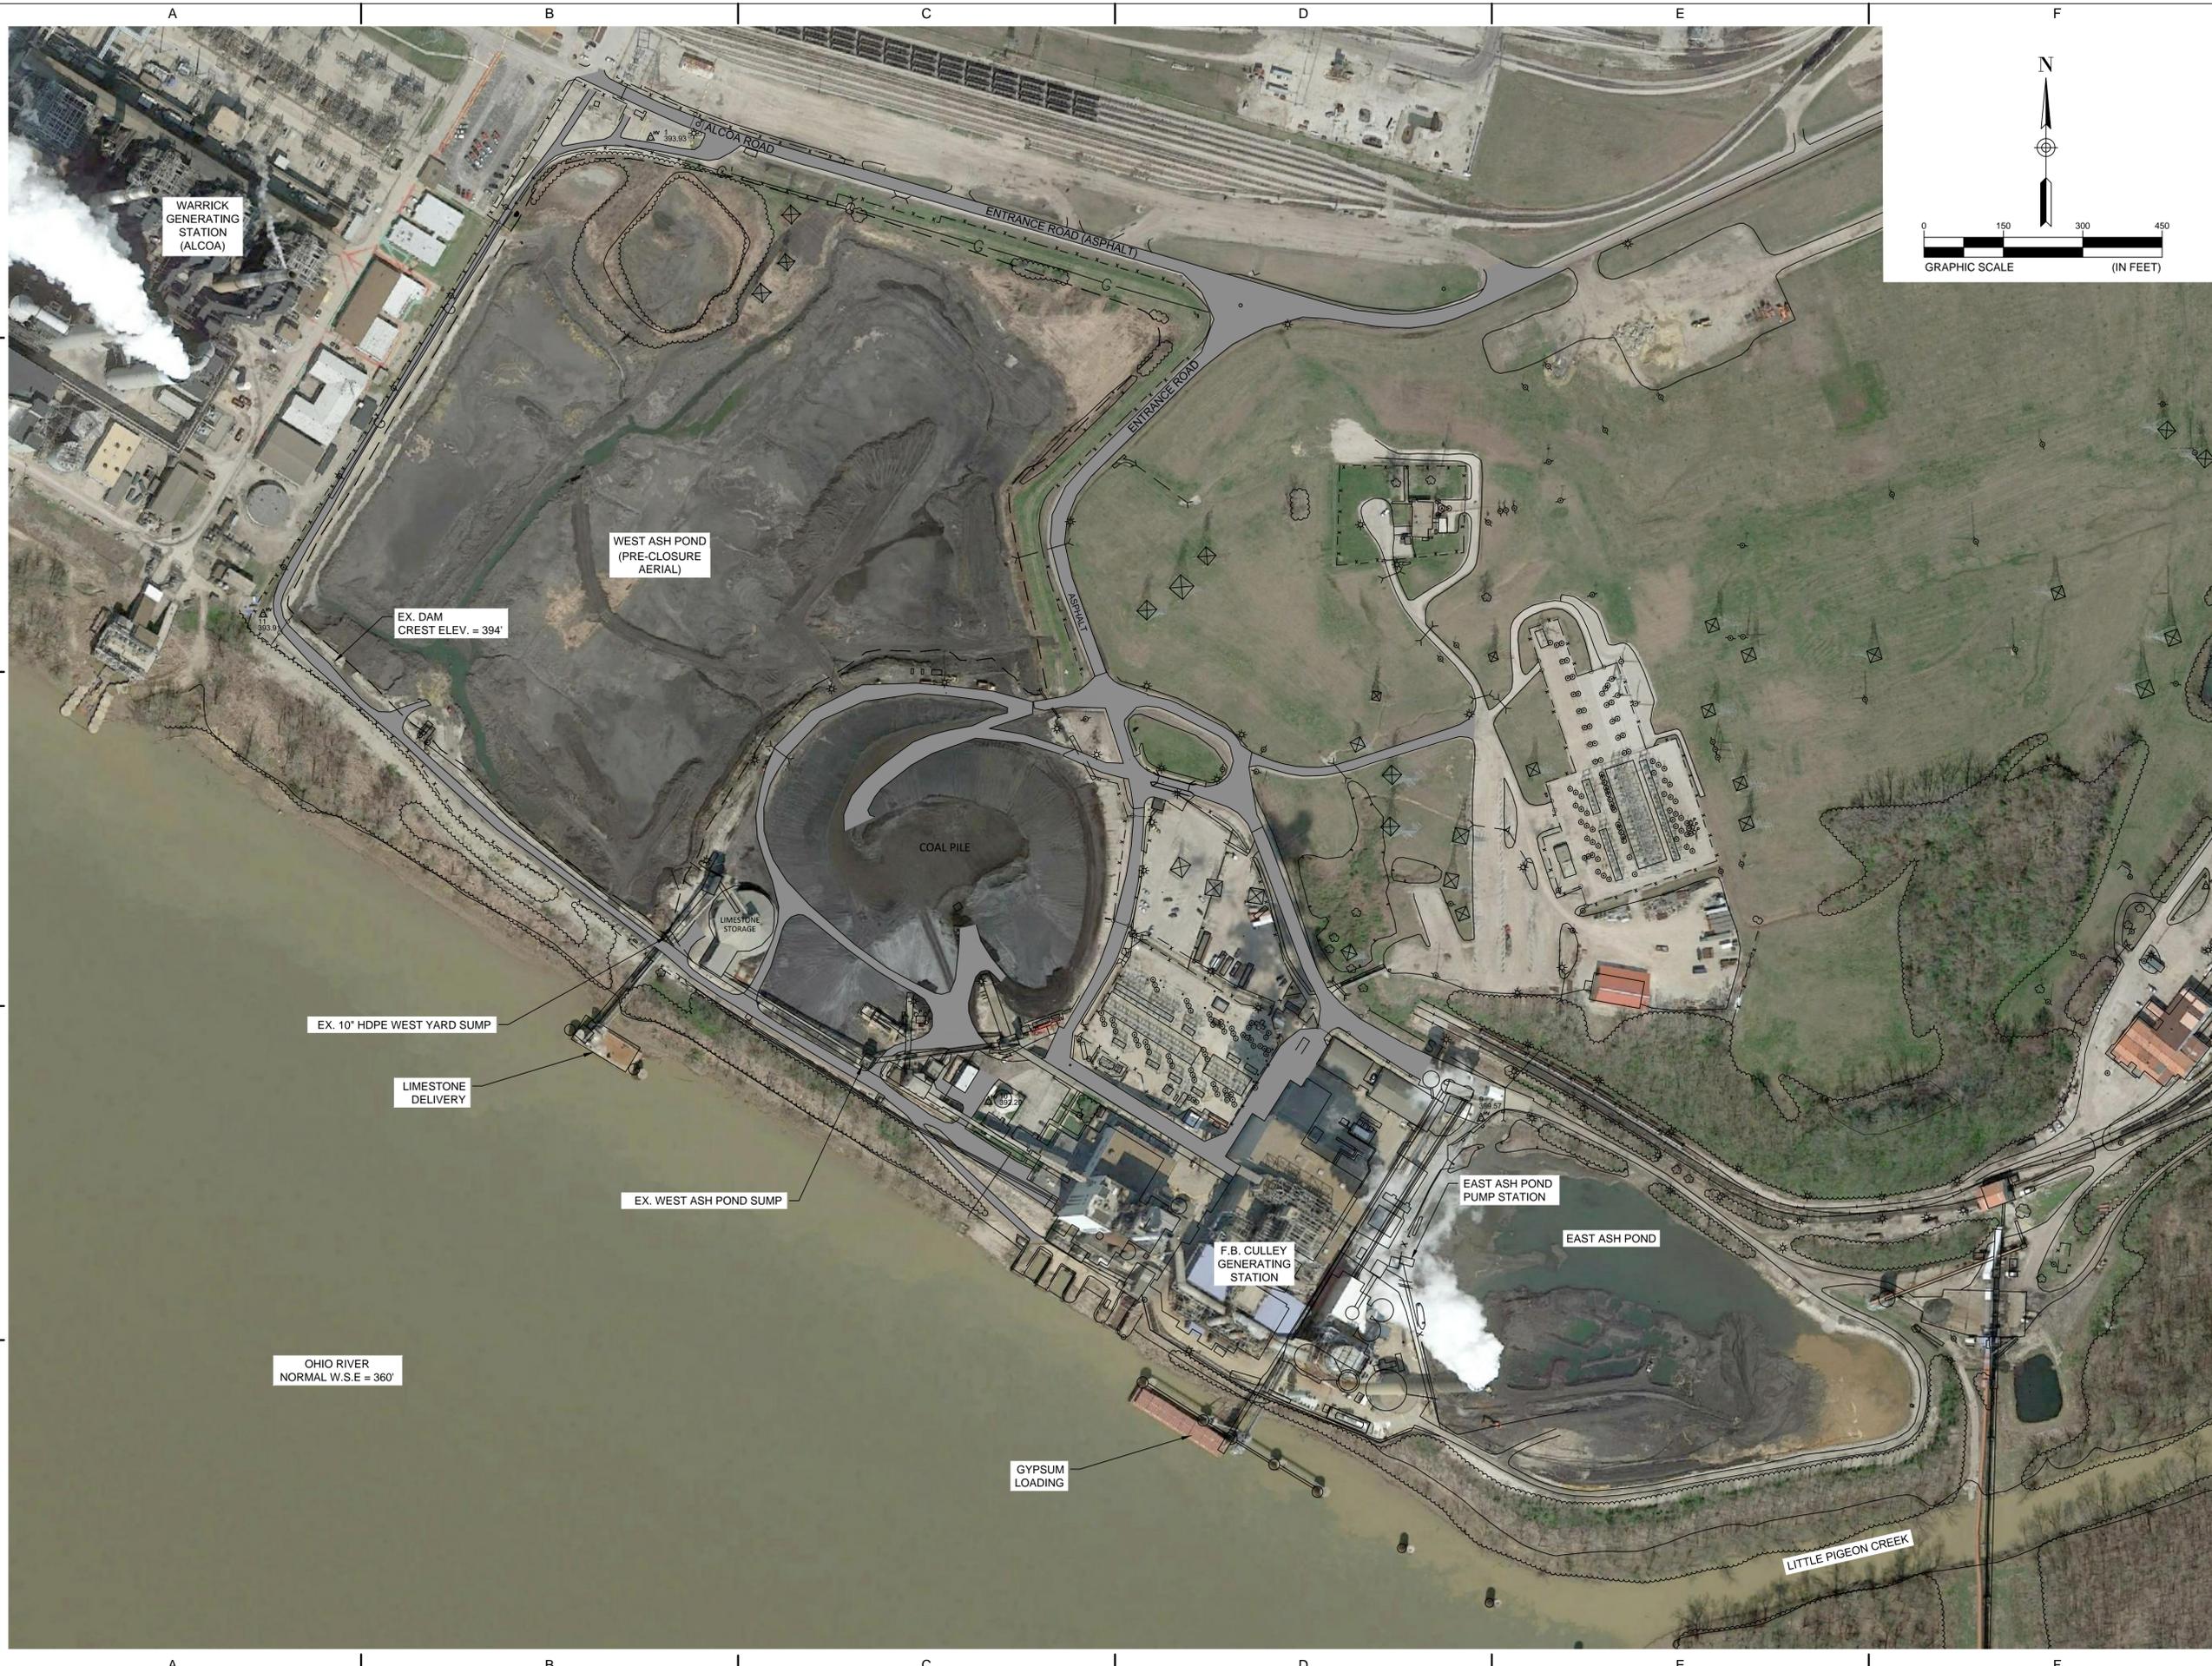
FIGURE 2

SITE MAP

A site Location Map showing the area surrounding the Station is included as **Figure 1** of **Appendix A**. **Figure 2** in **Appendix A** presents the Culley Site Map.
